The 70th Anniversary of the Tangiwai Railway Disaster – A Volcanic Dam Break Story

THIS PAPER WAS ORIGINALLY PRESENTED AT THE ASSOCIATION OF STATE DAM SAFETY OFFICERS 2023 CONFERENCE, AT PALM SPRINGS, USA ON 17-21 SEPTEMBER 2023 AS PART OF THE DECADE DAM FAILURE SERIES. IT WAS REFORMATTED FOR THE 70TH COMMEMORATION OF THE TANGIWAI DISASTER IN NEW ZEALAND IN DECEMBER 2023

JULIANA TABET, M.SC., P.ENG., SR. DAM ENGINEER, HATCH LTD.; MARK BAKER, P. E., INDEPENDENT CONSULTANT, DAMCREST CONSULTING; AND HARRY KEYS, PH.D., O.N.Z.M., RETIRED EARTH SCIENTIST.

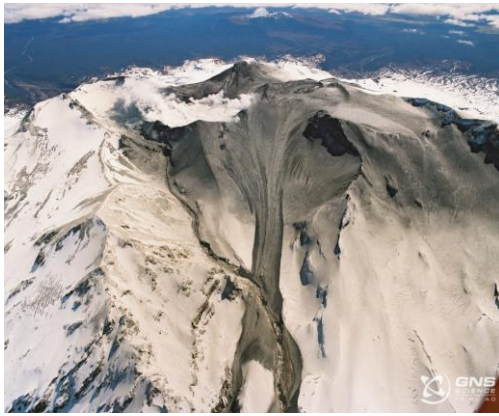
Photo 1 – Mount Ruapehu lahar, following eruption 24 September 1995 by Lloyd Homer (copyright GNS Science)

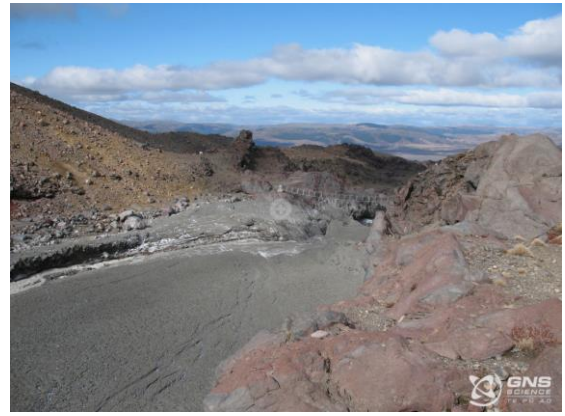
Photo 2 – Lahar deposits in Whangaehu Valley, Ruapehu, following Ruapehu eruption on the night of Tuesday 25 September 2007 by Vern Manville (copyright GNS Science / EQC)

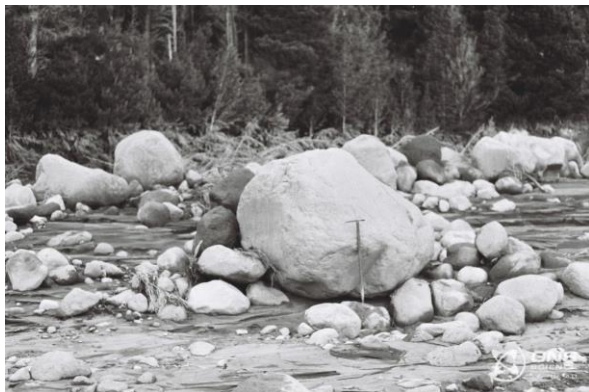
Photo 3 - Whangaehu River boulders on April 28, 1975, by Brad Scott (copyright GNS Science)

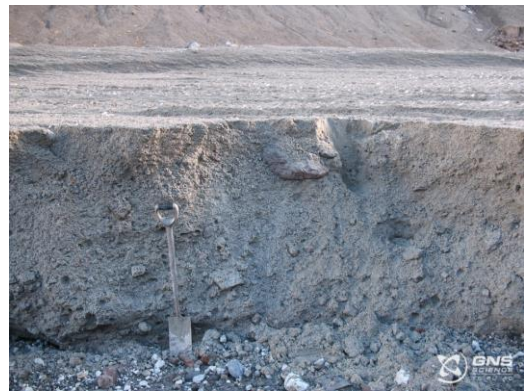
Photo 4- Lahar deposits in Whangaehu Valley, Ruapehu on September 26, 2007, by Vern Manville (Copyright GNS Science / EQC)

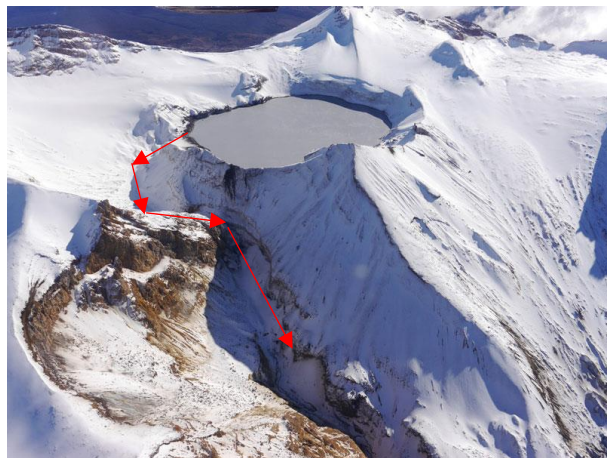
Photo 5 – Mount Ruapehu Crater Lake (Source: GeoNet / Copyright of GNS Science – <https://static.geonet.org.nz/info/images/volcano/Ruapehu-Crater-Lake.jpg>) – the red arrow indicates the Whangaehu River

Originating from the Lake, the river's outlet is located on the southeast rim – see Photo 5. It flows eastward through a gorge and across an alluvial fan before taking a curve and turning south. After a journey of 160 km from its source, the Whangaehu River finally reaches the Tasman Sea.

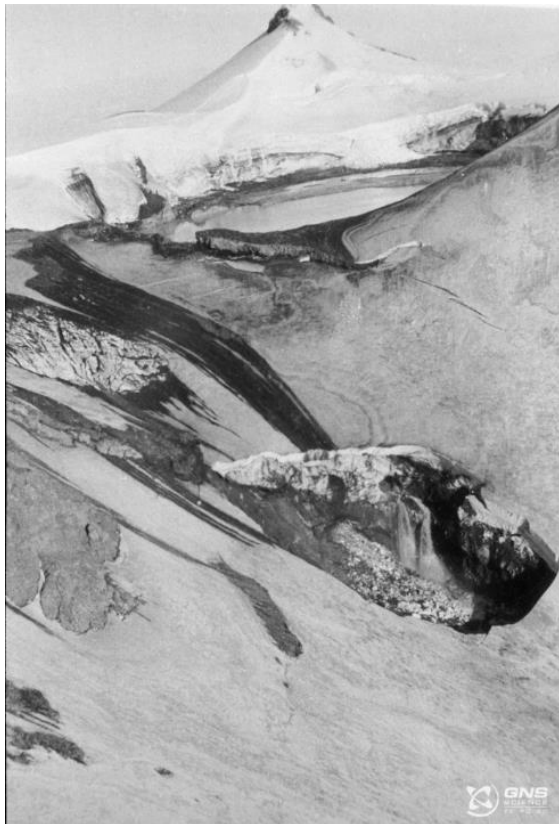
It is believed that while the lake was discharging through the first formed cave – believed to be about 4m to 5 m in diameter [7] -, the water was also seeping around and through the volcanic lava, ash and scoria alongside to form another channel beneath the ice at a lower level. Erosion of this channel may have weakened the volcanic barrier, while cracking movements in the ice above could have triggered a sudden collapse of the ash barrier. An observed ice bridge in the Whangaehu Glacier was likely thin, and when the mass of water from the Crater Lake surged down the channel, the vibrations and pressure may have caused the ice to crack and shatter or a temporary blockage beneath the ice to increase pressure until it gave way [7, 12].

Photo 6 – Mount Ruapehu Crater Lake Outlet after the Tangiwai Disaster on December 28, 1953 (Copyright GNS Science)

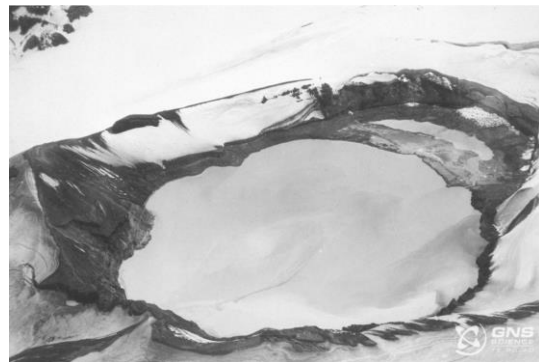
Photo 7 – Mount Ruapehu Crater Lake after Tangiwai on December 28, 1953 (Copyright GNS Science)

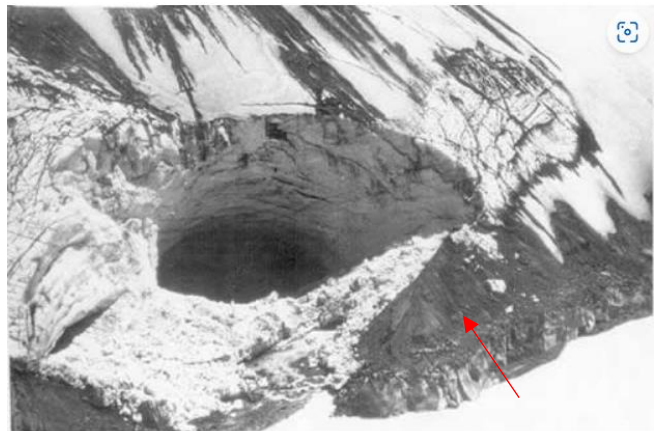
Photo 8 – Ruapehu Crater Lake outlet after the Tangiwai disaster on Dec 28, 1953 – the red arrow indicates the breached 1945 lava and tephra/debris layers (Copyright GNS Science)

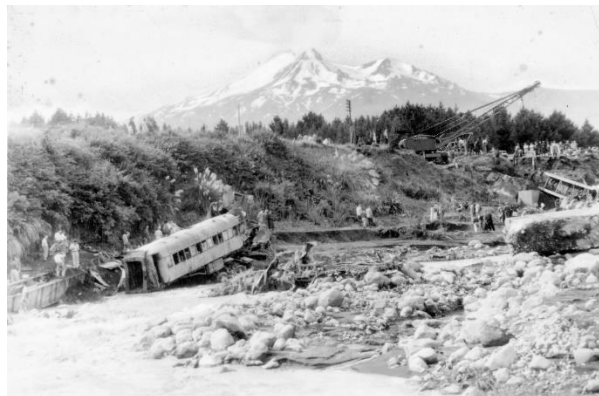
When the lahar reached the bridge, it is believed to have washed away Pier 4, leading to the collapse of spans 3 and 4 into the river. The water level at the bridge rose by 4.5 to 5.2 m or 6 m allowing for uncertainty [5, 7]. It is believed that span 3 girders were struck by the waves, as the flood water was measured above the elevation of the bottom flange of girder 3. Lateral and diagonal forces on the pier then caused it to fracture at a construction joint, and the upper portion was then forced upwards and sideways. When the lower portion of the pier was relieved of most, if not all, of the vertical forces from above it was swept away by the flood. As a result, the upper portion of the pier and spans 3 and 4 were then unsupported and fell into the raging waters [26, 27].

Photo 9 - The scene at the site, looking toward the west - Dec 25, 1953, Mount Ruapehu in the background (Copyright Graham Stewart)

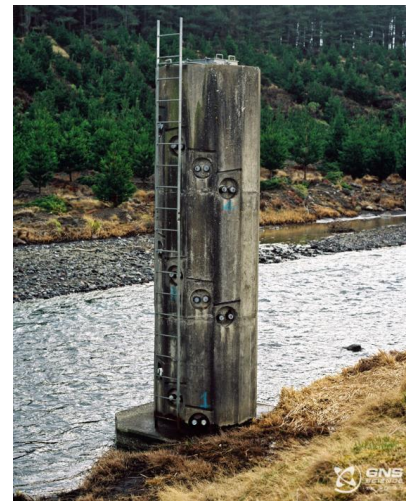
Photo 10 - Rail lahar warning system, Whangaehu River, Taupo Volcanic Zone by Lloyd Homer (Copyright: GNS Science)

In 1969 Mount Ruapehu erupted again, without warning, generating a lahar that failed to register at Level 1. The warning system had failed. Again, in the 1975 another unheralded eruption occurred, releasing a lahar which travelled at an average speed of 25 km/hr, with peak flood velocity estimated to be 43 km/hr and the peak flow 5000 m³/s. Within 2 or 3 minutes the Whangaehu River rose from normal flow to above the gauge maximum at circa 5 m above normal river level [28, 29]. This time the alarm was successful, but the alarm only alerted the rail station of the incoming flood waters. Apparently there was no warning given to or integration with other stakeholders.
